Manhole Inspection Summary

Manhole # S31QQ_020MH

Insp Date: **4/30/07 10:10 AM**

Location Address: **2600 26TH ST**

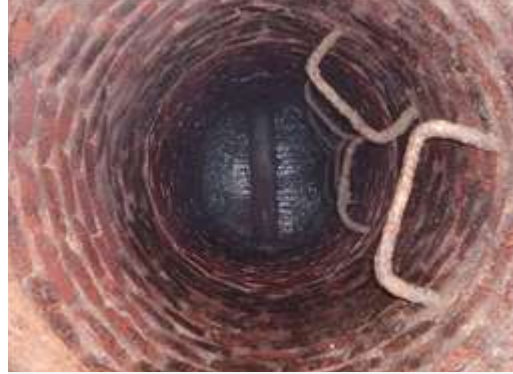
Top View

☐ Parged ☒ **Debris** (not Condition related)

Steps Count: **12** Missing: **0** ☒ **Corroded**

Corroded steps. Bench debris.

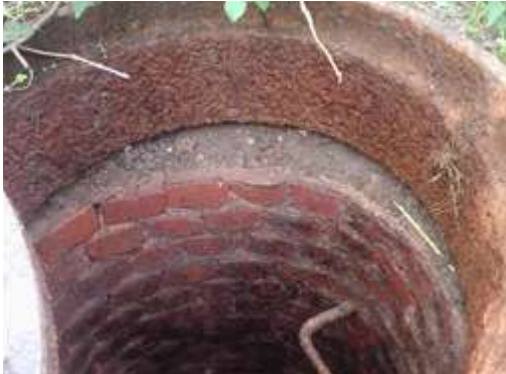
Defect

Frame Offset: **3** (in.)

☒ **Leaks**

Condition: ☐ Sound ☐ Cracked ☒ **Root Intrusion** ☐ Loose Brick ☐ Deteriorated

Infiltration: ☐ None ☒ **Joint** ☐ Cracks ☐ Mortar ☒ **Roots** ☒ **Wall**

Infiltration: ☐ None ☐ Joint ☐ Cracks ☐ Mortar ☐ Roots ☒ **Wall**

Frame leaks. Frame offset. Adjustment root intrusion and infiltration. Barrel infiltration.

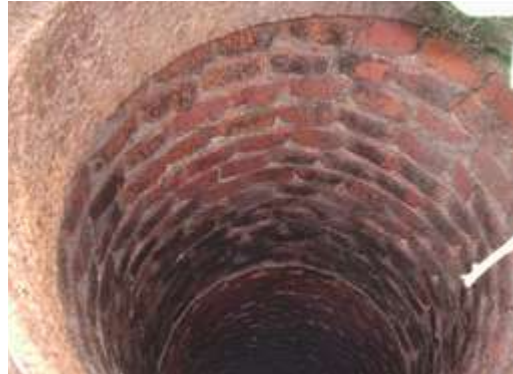
Defect

Frame leaks. Adjustment root intrusion and infiltration. Barrel infiltration.

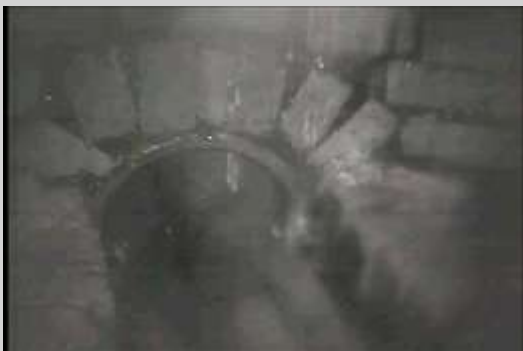
8 in. Circular Gravity Sewer Pipe In @ 6 O'Clock

Infiltration: **Evidence** Pipe Seal Cond: **Unknown**

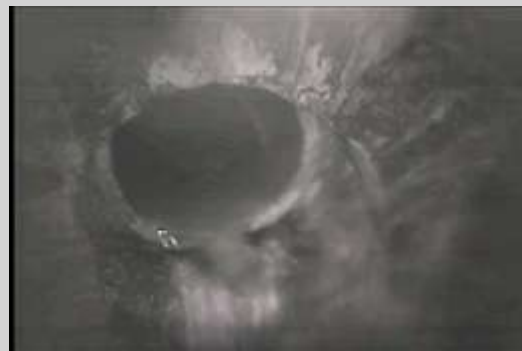
Drop In @ 6 O'Clock

Drop Condition: **Clogged**
